AN ARGUMENT FOR FULLY ENGINEERED POST-FRAME BUILDINGS

By David Bohnhoff, PE, PhD
University of Wisconsin

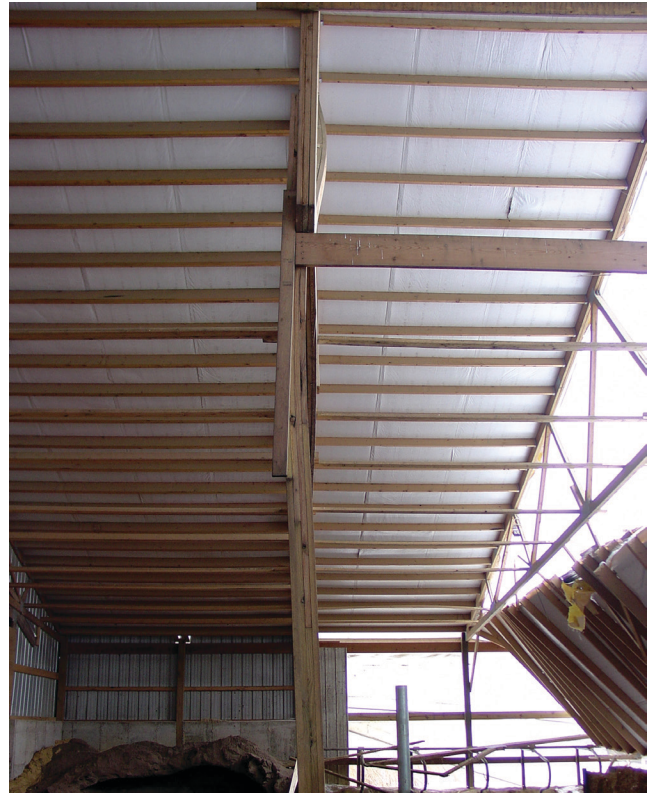
Figure 1: Buckling of a nail-laminated post due to improper design. Also visible is the buckling of the compression web chords due to improper bracing.

A prime example of the problems this causes was on full display in Myren's freestall barn and the other five failed buildings I visited the same day. Many of these buildings had seriously under-designed interior columns. As constructed, most of these columns would have an allowable axial design load of zero (0) which explains the classic buckling observed (figure 1). Other major deficiencies included no column sideway control at connections between interior columns and trusses, no accounting for additional loads induced by drifting snow and improper truss web bracing. With respect to the latter, all buildings I inspected with roof trusses utilized continuous lateral restraint (CLR) systems to brace longer compressive web members. Unfortunately, every CLR system was improperly installed, as none of them included diagonal bracing to prevent CLR shifting. This resulted in web buckling (figure 2) and subsequent truss failure.

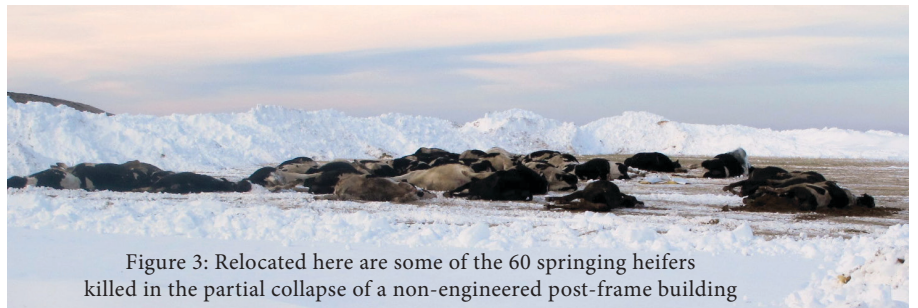
Figure 3: Relocated here are some of the 60 springing heifers killed in the partial collapse of a non-engineered post-frame building

I believe it is unethical to sell larger buildings that are not fully engineered. Not only does it needlessly endanger farmers, but a lack of building engineering is responsible for the deaths of numerous animals every year. I've been in buildings with thousands of crushed chickens. I've also seen my share of dead cattle (Figure 3).
